Re: September 2013 Monthly Progress Report  
Administrative Settlement Agreement and Order on Consent for Removal Action  
U.S. EPA Region 10 Docket No. CERCLA 10-2009-0255  
Gasco Sediments Site within the Portland Harbor Superfund Site

## Visual Observations Log Form

**Monitoring Period:** Monthly (Year 7)—September 2013

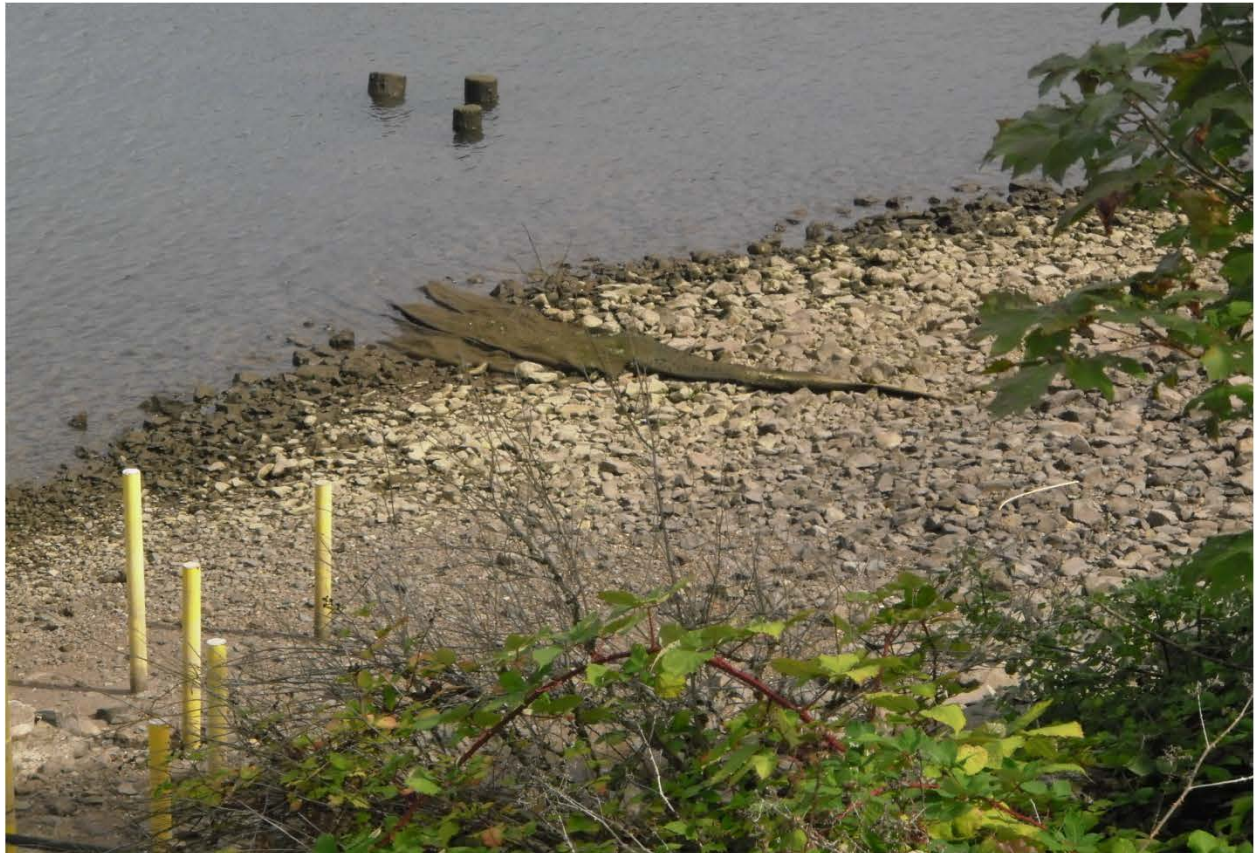
**Observations of Erosion/Deposition:** No erosion/deposition is evident along the shoreline. Three organoclay mat material segments are exposed and visible. Ten feet of a 20-foot section of organoclay mat is out of the water at the upriver extent of the cap area (perpendicular to the shoreline, Photo 1). A segment measuring 4-foot in length is seven feet from shoreline near the lateral mid-point of the cap area. One 40-foot section of organoclay mat material is exposed and half is out of the water and the other half is submerged beneath 0-1 feet of water near the downriver extent of the cap area.

Photo 1 — *Visible section of organo-clay mat near the upriver extent of the cap area (9/25/13):*

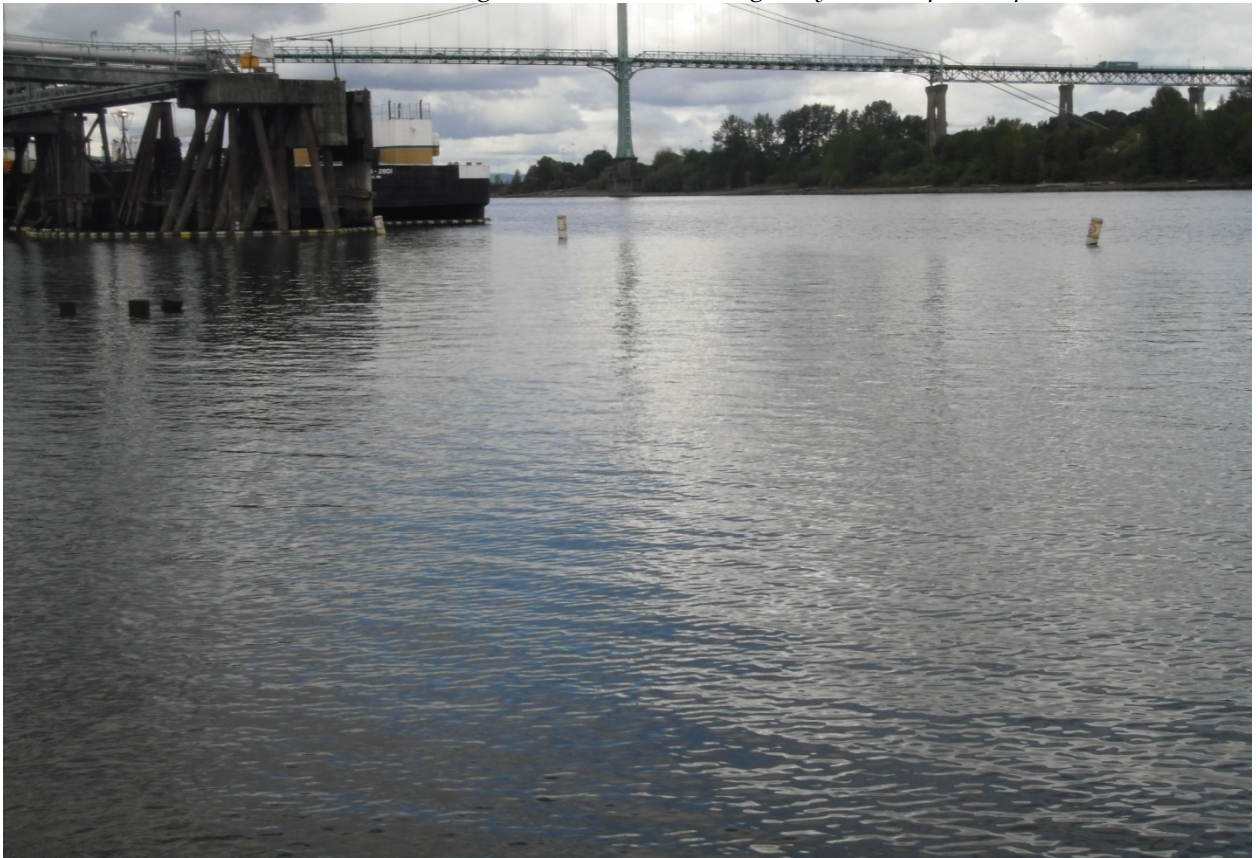
**Observations of Long-term Controls (i.e., oil booms, organo-clay mat, etc.)** During the observation, a barge was tied at the pier and the Fuel and Marine Marketing (FAMM) containment boom was placed around the barge during refueling operations. Buoys that identify the cap area to mariners are in place as installed. The position of the FAMM oil boom, warning buoys, and a general overview is shown in Photo 2.

Photo 2 — *FAMM oil boom around barge and mariner warning buoys across pilot cap area. (9/25/13):*

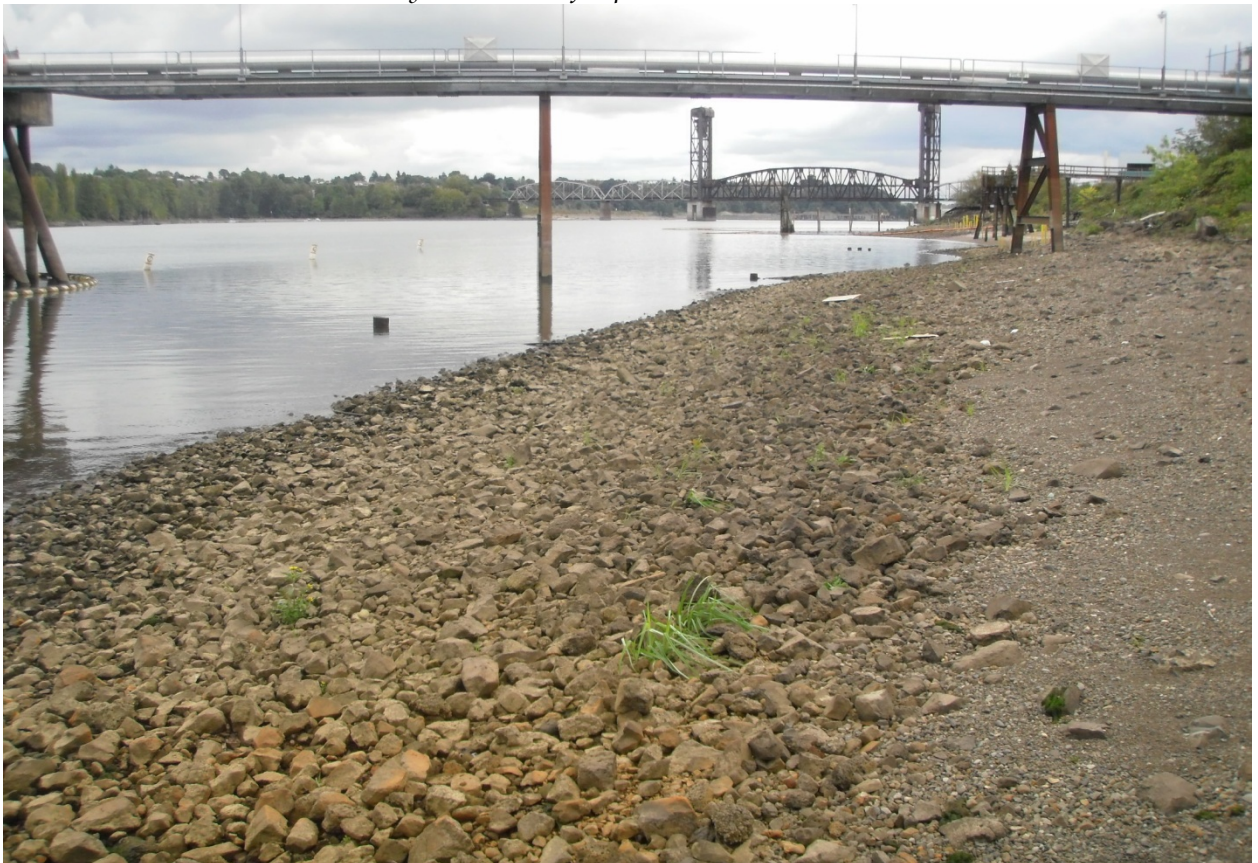
No sheen is evident in or around the cap area. Photo 3 shows the water surface and shoreline immediately downriver of the sediment cap.

Photo 3 — *Conditions immediately downriver of cap area (9/25/13):*
